PRODUCT DESCRIPTION

Gland body

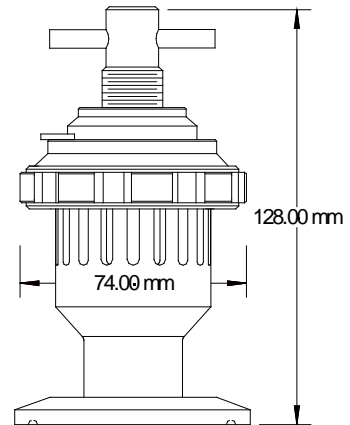
Material : machined from 316L stainless steel round bar stock with the bore finished to 0.5Ra (25µ inch).

Process connection : 1", 1½", 2", 2½" or 3" Tri-clover flange.

Capacity : TCEG/1, 18 thermocouples, TCEG/2, 36 thermocouples.

Thermocouple slots : 4.0mm wide.

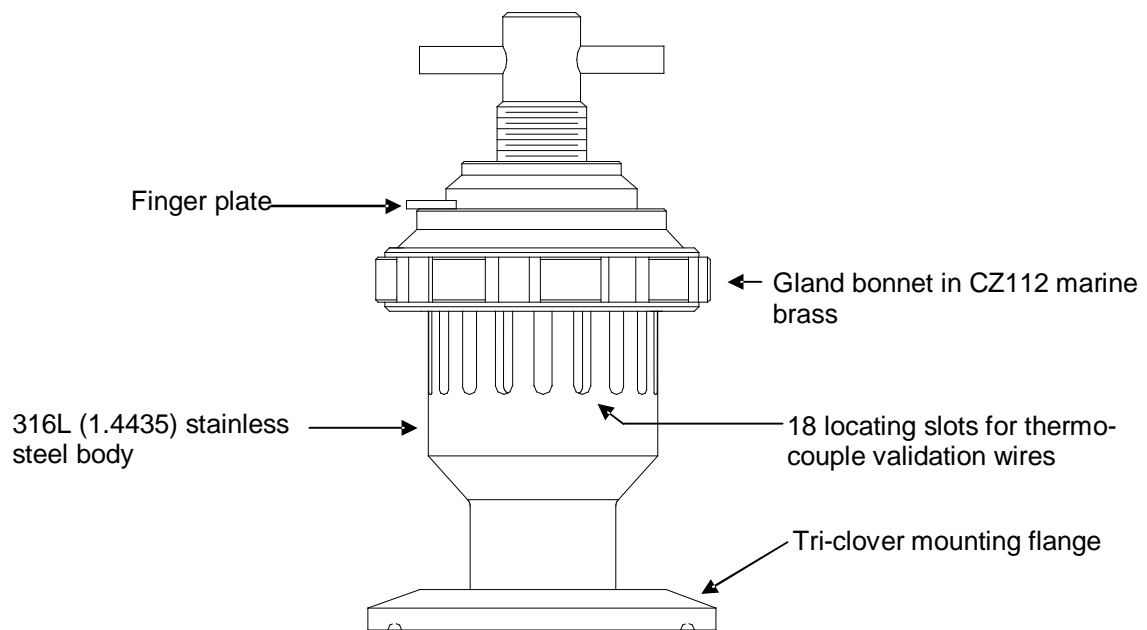
Gland bonnet

Material : cap is machined from CZ112 marine brass and the compression nose from CZ121 brass round bar stock with spring loaded quick release locking mechanism in 316L (1.4435) stainless steel.

Sealant ring and cap

Material : medical grade silicone to Shore 40 hardness and in accordance with FDA USP Class VI.

Removal of the brass gland bonnet is effected first by unscrewing the stainless steel screwed bolt until approximately 17mm of thread is visible above the brass surface. Raise the stainless steel finger plate and rotate the bonnet in an anti-clockwise direction until it reaches its stop. At this point the three sets of three hooked splines of the gland body are clear of the catchment lips and the bonnet can be lifted off.

Before replacing the brass bonnet ensure that the stainless steel screwed bolt is screwed back until 17mm of thread is showing above the brass surface. The bonnet can now be re-fitted by placing it above the splines of the stainless steel body and gently rotating it in a clockwise direction until it drops onto the lower splines.

The stainless steel screwed bolt should then be turned in a clockwise direction which forces down the compression nose against the upper silicone seal. This action compresses the silicone seals around the thermocouple jackets which are then securely held and sealed against chamber pressure.

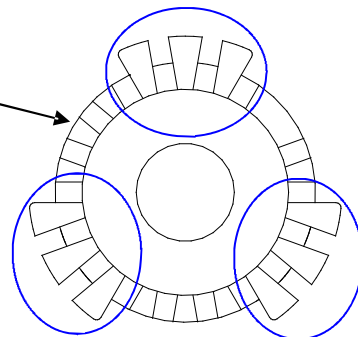
Plan view of body with gland bonnet removed

18 locating slots for thermocouple validation wires

Three groups of three locating spines for brass gland bonnet locking mechanism
